BSA SERVICE SHEET No. 807

All Models

ELECTRIC HORN—HIGH FREQUENCY MODELS

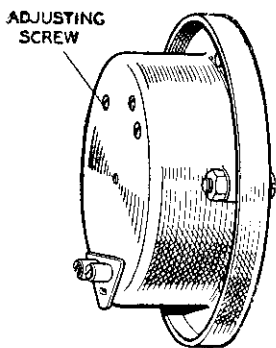
Fig. Y26.
Typical electric horn, showing
adjustment screw.

After adjusting, note the current consumption, which must not exceed 3—4 amperes. A horn may give a good note, yet be out of adjustment and taking an excessive current. When adjusting do not attempt to unscrew the nut securing the tone disc or any other screw in the horn.

The adjustment is made by turning the adjustment screw, usually in a clockwise direction. The underside of the screw is serrated, and the screw must not be turned for more than 2 or 3 notches before re-testing. If the adjustment screw is turned too far in a clockwise direction, a point will occur at which the armature pulls in but does not separate the contacts.
